LOTES DAM
WAYNE COUNTY, MISSOURI
MISSOURI INVENTORY NO. 30309

PHASE I INSPECTION REPORT
NATIONAL DAM SAFETY PROGRAM

AUGUST 1979

Name of Dam	Lottes Dam
State Located	Missouri
County Located	Wayne County
Stream	Unnamed tributary to West Fork Creek
Date of Inspection	17 May 1979

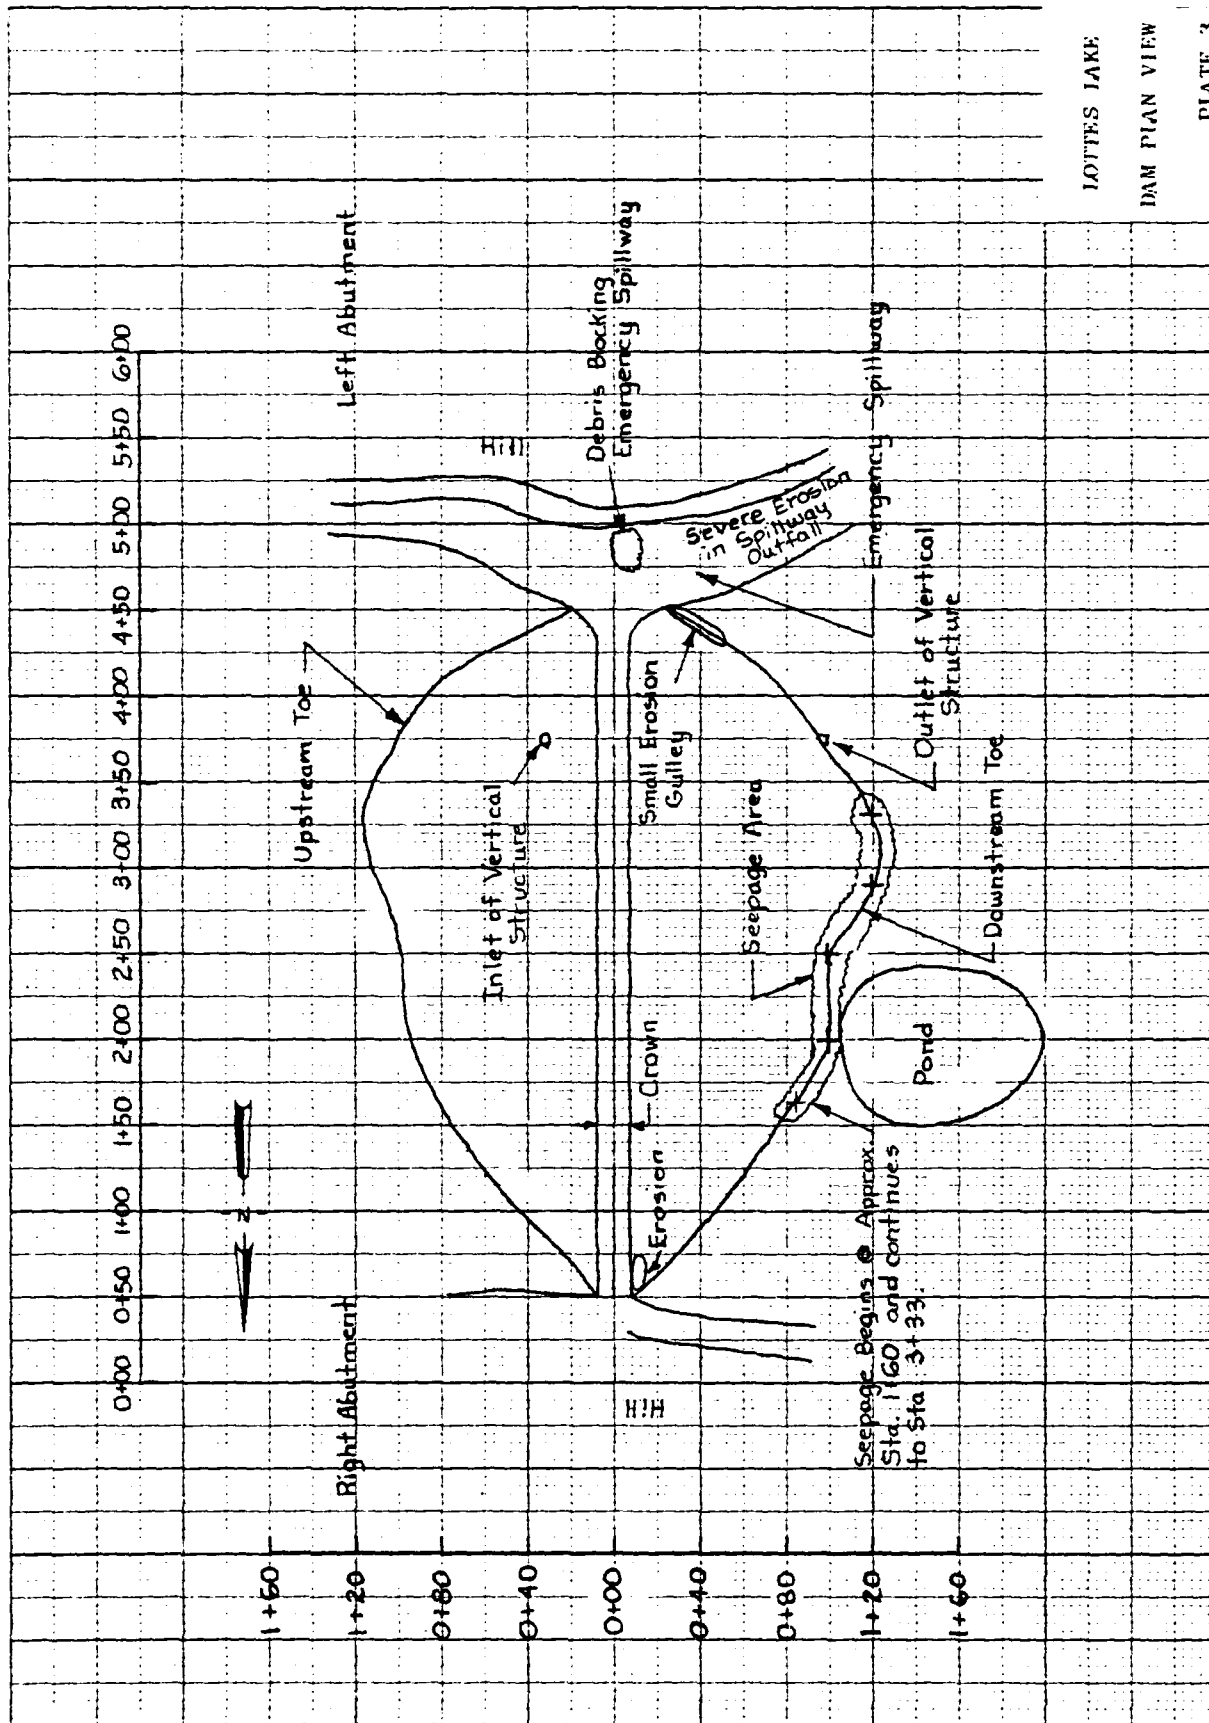
PLATE 3

Seepage was observed flowing from several locations at the toe of the dam from Sta. 1+60 to Sta. 3+33 (see Plate 3). There was also slight seepage flowing from the right abutment. Seepage was estimated to be approximately 5 gpm from each of the locations except at Sta. 2+90 where the seepage was estimated to be 20 gpm. All of the seep water, except that flowing from the right abutment, was reddish in color, indicating flow through a high iron content soil. None of the seepage appeared to be piping any material from the embankment or foundation. Seepage from the right abutment and at approximate Sta. 2+00 was used to feed a pond constructed at the toe of the dam near the right abutment (see Plate 3 and Photo 14). The pond is used to water stock and as a minnow pond. The pond follows the toe of the dam for approximately 75 feet and extended approximately 100 feet perpendicular to the dam. According to the owner the seepage began after the construction of the dam, but it has decreased approximately 80% during the life of the dam.
